STATUS OF GULLY REHABILITATION: A CASE STUDY FROM WEST TENNESSEE

MICHAEL L. BARNHARDT Memphis State University Memphis, TN 38152

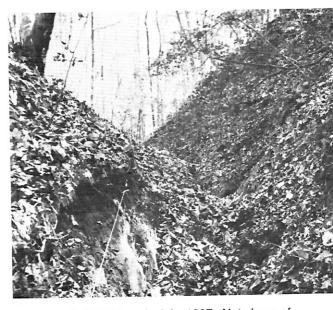
Figure 1. Gully hillslope in July, 1987. Note base of tree in uppermost right.

Slumping is common on the steep, loess slopes in the park. In December, 1987, a 250 mm rainfall over a 36-hour period triggered three large slumps in the study area which buried almost completely the three dams that were only then being reexposed from their burial 50 years ago. Two of the slumps were initiated by or accompanied large treefalls. Figures 1 and 2 illustrate the effects of treefalls on hillslope morphology.

As many researchers have stated, it is far easier and cheaper to prevent erosion than to correct the problem once it is established. Aside from the funding problems faced by all public agencies, the control of soil erosion and gully development in this park area lies in the realization that a short-term solution may not be available. In fact, many of the attempts to control gully activity near the headcut where it abuts roadways are detrimental to the cause. The large quantities of sediment-free water that drain into gullies from roadways undermine the headcut causing block falls and slumps. The high-energy water continually removes this sediment exposing the base of the cut to renewed undermining. Since the sediment is not allowed to slump and settle into the channel creating a lower angle of repose, vegetation can not establish itself and stabilize the sediment. Additional problems are created along the expanding upper reaches of the gully network where mature trees are being undercut. Remnants of the pre-settlement forest, these large trees frequently dislodge many cubic meters of sediment during treefall (see Figures 1 and 2).

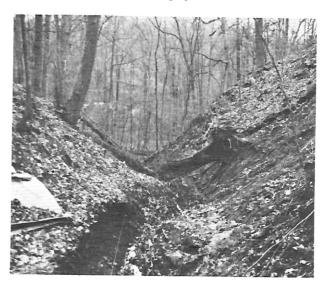
Figure 2. Gully hillslope in January, 1988. Tree from upper right has fallen. The thickness of the slump is closely related to the depth to a clay-rich soil horizon.

The dense seasonal canopy has little effect on raindrop impact during the winter. The intense rainfall in late December fell upon soil already saturated from previous rains in early December. Much of the sediment and organic debris was deposited on the gully bottom only a few meters downsteam of its point of origin. The method of deposition is very similar to that which I believe was
